A CASE HISTORY

Warehouse foundation settlement recovered 22 inches

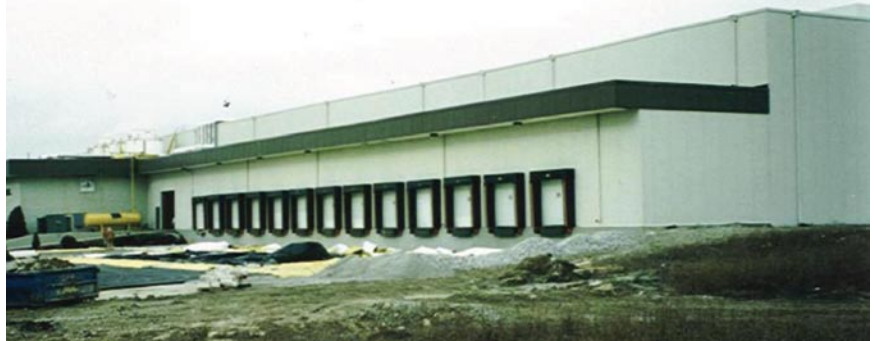
This is a view of the front of the structure. The loading dock shown here had settled 8 inches. Some areas at the right side of this building suffered settlement in excess of 22 inches!

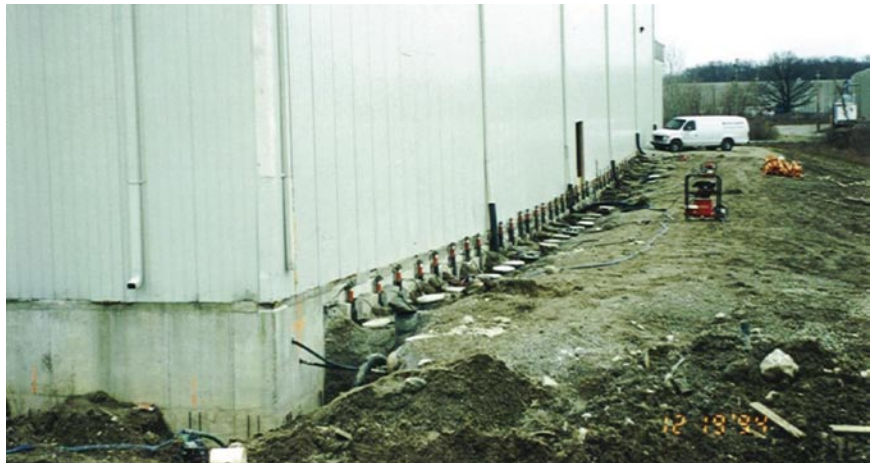
The photo above shows the right side being carefully and gently lifted. Note the hydraulic rams on each pier.
