A CASE HISTORY

Restore a Settled Pedestrian Bridge

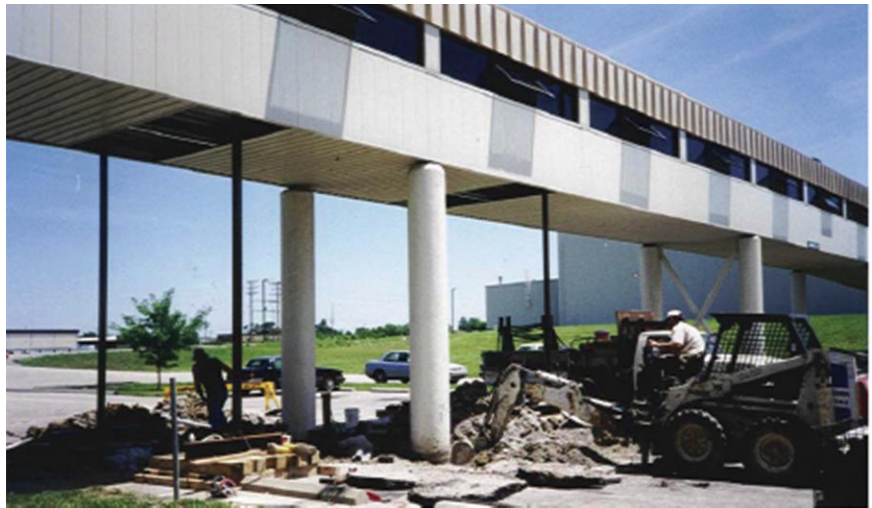
Excessive settlement was observed at two of the columns resulting in an obvious sag in the structure, cracks in the drywall and buckling of the ceiling tiles. The pavement around the columns was depressed, which allowed for ponding water. The engineers estimated settlement at 3 to 5 inches.

A review of the topographic survey by the engineers indicated that a line of karst ("sinkhole") depressions passed between the manufacturing buildings connected by the walkway. The walkway traverses the edge of the deepest of the filled depressions. Soil borings near the

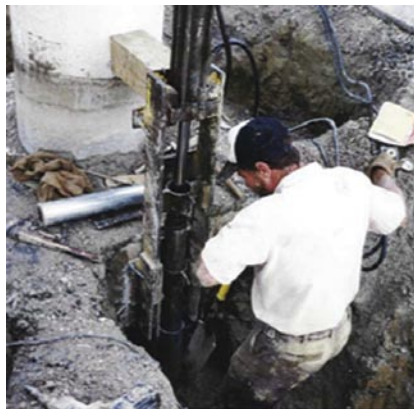
Quick installation: Technician installs one of the four Atlas Resistance® Piers that supported and restored the footing and column. Notice that the hydraulic drive cylinder, the pier pipe and the pier head are carefully maintained in vertical alignment.

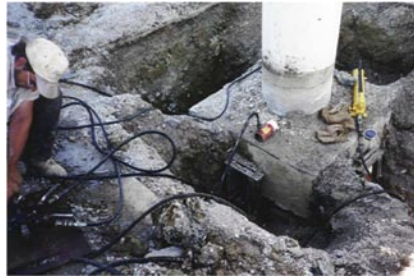
Gentle, accurate lift: After each pier is driven to a suitable bearing stratum and tested (please see Installation Summary), the piers are gently and uniformly lifted using a manifold system and a hand operated hydraulic pump. Technicians carefully monitor the piers at all stages of installation.

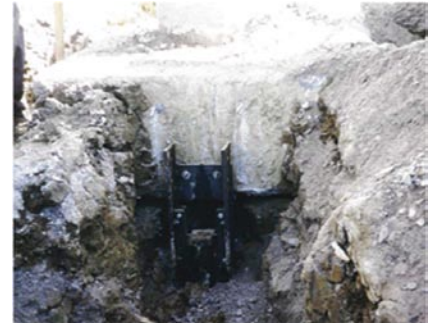
Success: Pier configuration after installation and restoration of the structure. Notice void below the footing indicating the 2-3/4 inch lift of the footing and structure.
