## A CASE HISTORY

**Project:**  
Zecca Plaza  
Gallup, New Mexico

**Foundation Repair Contractor:**  
Vic Peery Construction  
Albuquerque, NM

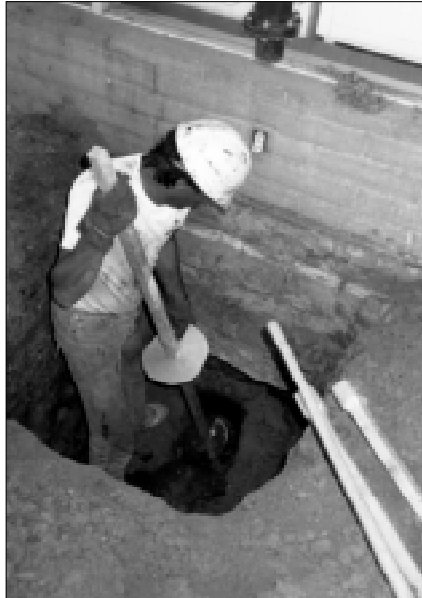
**Anchor being spotted next to foundation**

Every 6' to 8' the foundation was exposed to 1' below the bottom of the footing to allow for the installation of the twin helix (8" & 10") anchors and the underpinning bracket. Using a 6,000 ft.-lb. hydraulic motor mounted on a skid loader, the anchors were installed to depths of 35' to 40' to reach the bedrock material lying below the soft alluvium material.

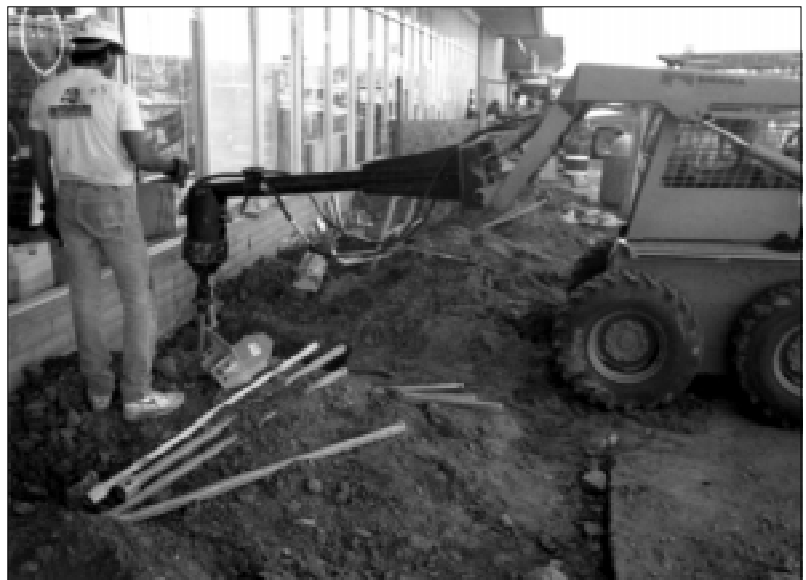
**Skid loader driving screw anchor to 40'**

To provide a 2 to 1 safety factor on the anchors for the 15 KIP working capacity of the underpinning bracket, the anchors were installed to torques averaging 3,000 ft.-lb. After installing the underpinning bracket body under the foundation and the T-pipe onto the anchor's 1 1/2" solid steel square shaft, the 2 nuts on the vertical bolts were tightened down to preload the foundation onto the anchors. The job was completed in less than 2 weeks with no disruption to customer traffic into the store.
