A CASE HISTORY

Chance Civil Construction Distributor:
Intech Anchoring Systems, Livonia, Michigan

Project:
Devos Residence
Renovation and Expansion
Grand Rapids, Michigan

Structural Engineer:
Soils and Structures
Muskegon, Michigan

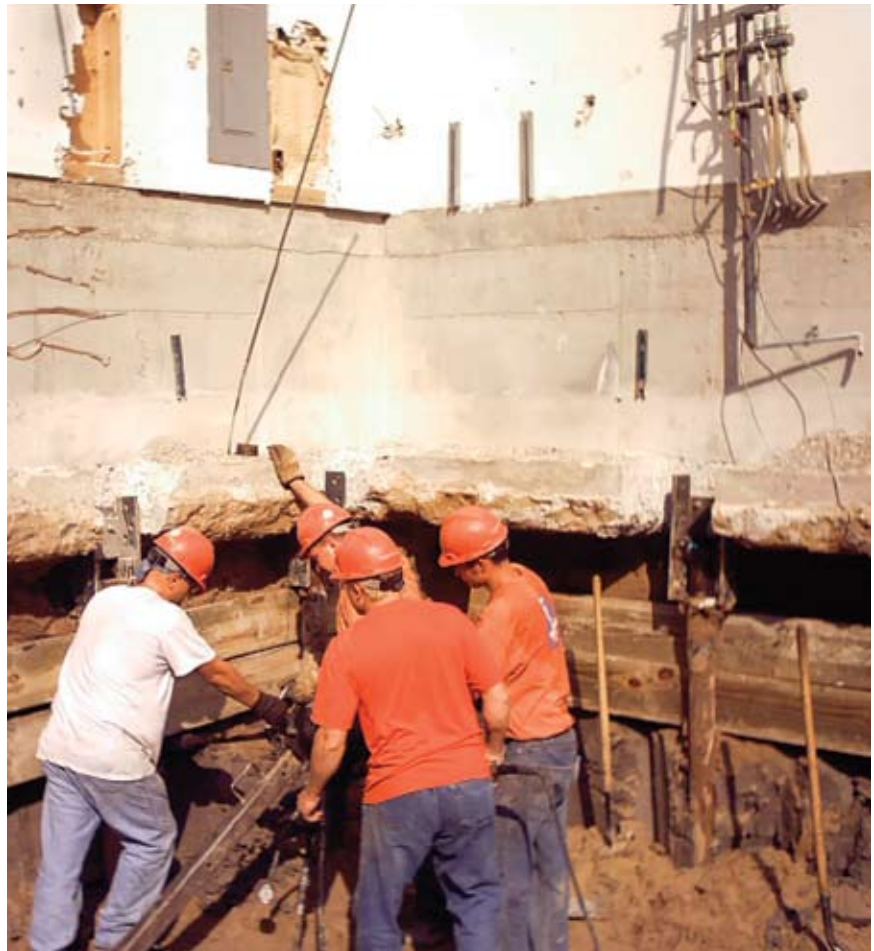
Installing CHANCE® helical tieback anchors between Atlas Resistance® piers

1. Installing 4"-diameter Atlas Resistance® piers installed on 4-foot centers with required depths more than 9 feet.
2. Sleeving pier shafts with three sections to exceed 9 feet.
3. Grouting the pier tubes.
4. Installing a CHANCE® helical tieback between the resistance piers and a 6"-wide steel channel waler to add tieback stiffness to the resistance piers.
5. Hand excavating behind the pier shafts and inserting wood lagging as the excavation was extended to the 9-foot design depth.

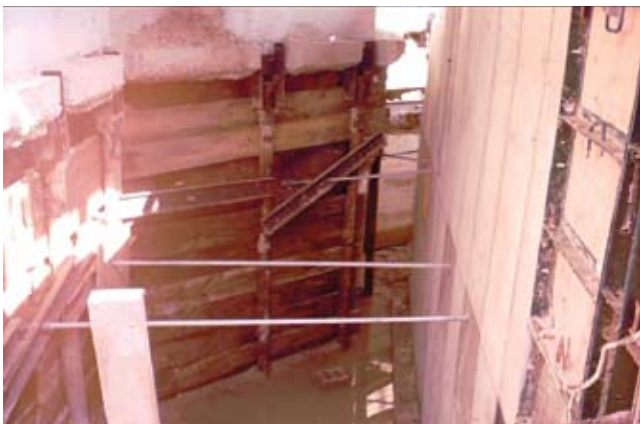
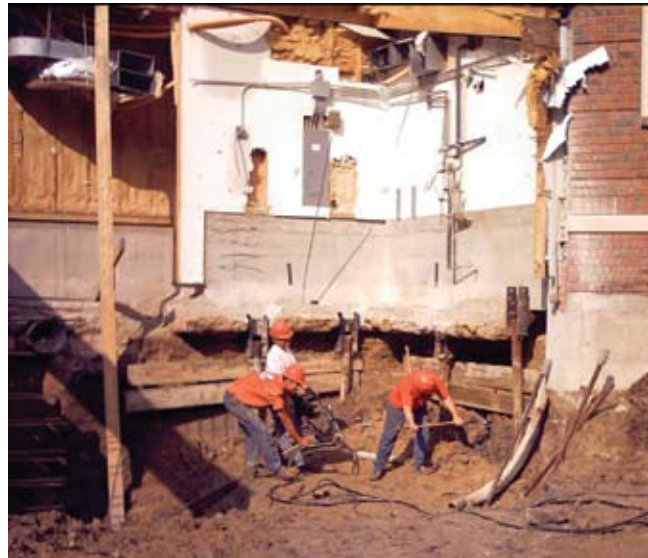
Adding an extension to a helical tieback anchor

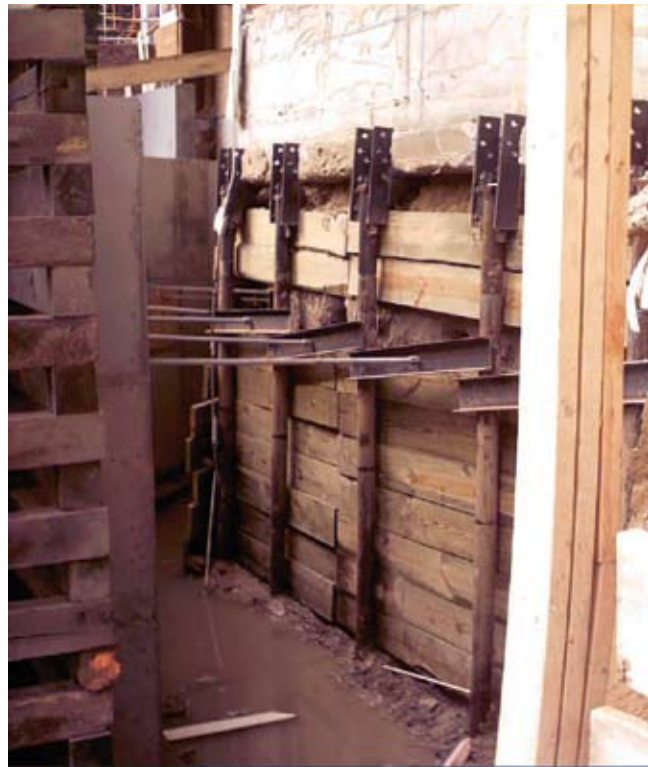
Tieback anchor rods extended to steel walers for lateral support during basement wall construction

Rods were extended from the shoring tieback anchors to provide lateral support required for the concrete contractor during construction of new basement walls in the area of the tiebacks.
