UNDERPINNING ANCHORING REPORT

A CASE HISTORY

Project: Elevated Residence Mandeville, LA	Geotechnical Engineer: Gore Engineering, Inc. Metairie, LA	Structural Engineer: Engineering Services, Inc. Slidell, LA	Anchor Contractor: Cornerstone Foundation Repair Covington, LA
--	--	---	--

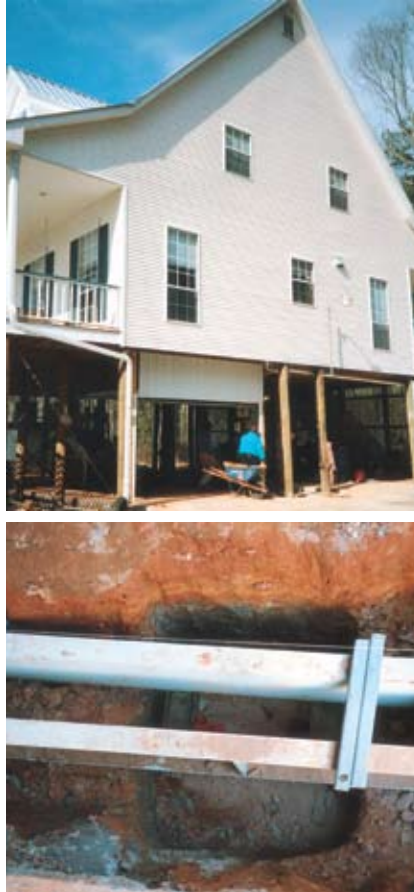
A 3-ft.-wide trench was excavated along each row of timber pilings. The timber pilings were notched at approximately 2 ft. below grade to accept two channels (C12 x 20). Notches were placed in the timber pilings so that after the lift, the channels would be level with the upper floor. The 45-ft.-long continuous channels were bolted to each timber pile with three 7/8-inch throughbolts.

Chance HELICAL PIER® Foundation Systems anchors were installed between the timber pilings. Each anchor had a 1½-inch square round-cornered steel shaft with four helices of 10, 12, 14 and 14-inch diameters. The installation unit was a Bobcat 853H equipped with a 12,500 ft.-lb. Eskridge drive motor and an ESI DP1 in-line torque indicator. Installed depths of the anchors varied from 20 to 30 ft. along the pile row farther from the river

and from 50 to 55 ft. along the pile row closer to the river. All anchors were installed to 5,300 ft.-lb. of torque.

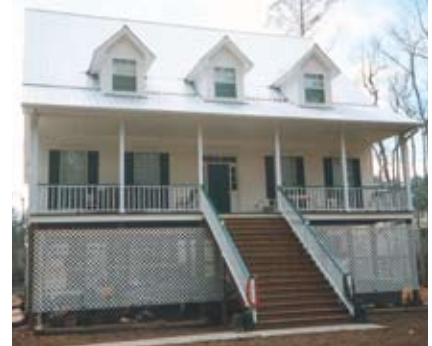
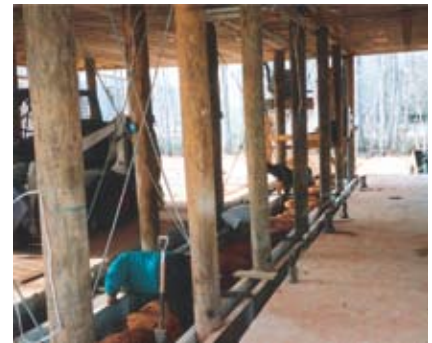
A pile cap area was excavated at a depth of 20 inches below the bottom of the continuous channels. The pile cap consisted of a reinforced channel assembly with a pipe sleeve for connection

to each anchor. This assembly was embedded in approximately 8 inches of grout in the haunch area.

Two hydraulic jacks were symmetrically positioned on either side of the anchors. The lift load consisted of two parts: The structure's dead load with furnishings plus the adhesion forces along the timber pilings. The structure was releveled to within a ¼-in. tolerance. The maximum lift was 5½ in. on the center two rows of timber piling.
