Mine Subsidence Repair

Stabilize house damaged by long-wall coal mining.

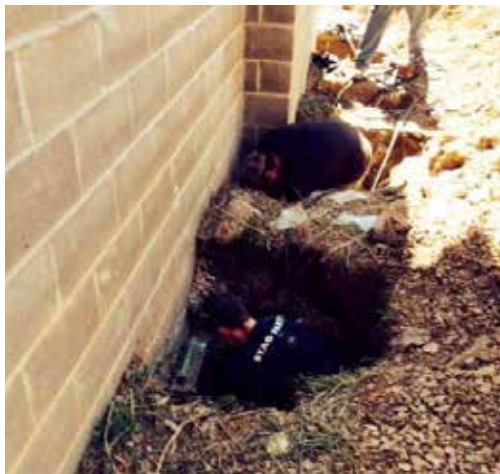
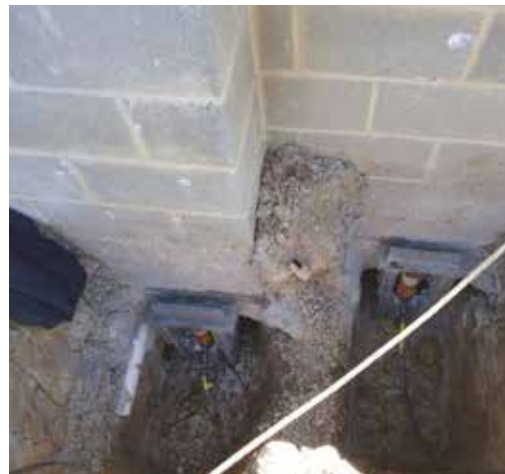
The homeowners built a new house in West Virginia in 2011, but it was not long before they noticed some problems. By 2012 it was clear that one corner of the house was dropping. Not good, but not unusual in an area known for its coal mines. By the time the ground stabilized in 2013, one basement wall was damaged beyond repair and the wood-framed house above was out of square and damaged.

Atlas Resistance Piers were installed outside of the house along one wall and inside the basement along another wall. To get to the footer, workers dug down on the outside of the house and cut through the concrete floor in the basement. Workers undermined the footer, where necessary, to mount the brackets and prepare for pile installation. The bracket is bolted to the underside of the footer and extends out besides the footer. The piers are installed vertically, through the bracket. Unlike Helical Piles, which are screwed in, Atlas Resistance® Piers are forced into the ground hydraulically.

Smith and his team installed 12 piers that were all 3-1/2 inch diameter pipe piers with one full pipe extension for a total depth of 7’ at each location.

The piers are driven in until the desired PSI rating is reached. At the Jones’ home, the design called for 4,500 PSI, all piers but one reached over 40,000 pounds of support per pier.
